# Manhole Inspection Summary

Manhole # S05WW1027MH

**Location** Address: **3408 ROCKWOOD AVE**

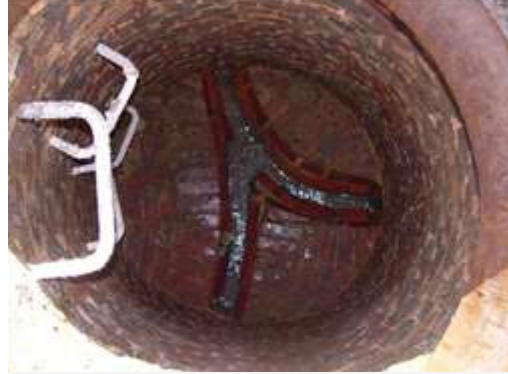
Top View

Evidence of surcharge - Bench debris.  
Channel debris.

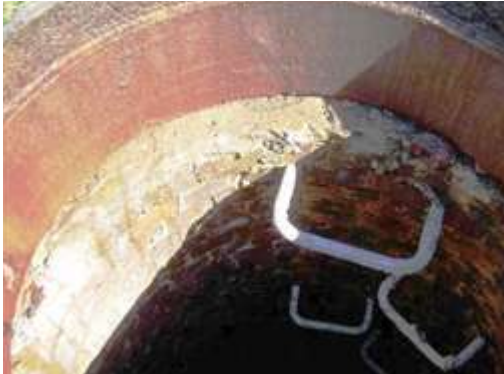
Defect

Frame leaks. Adjustment deterioration,  
loose brick and infiltration. Corbel  
infiltration.

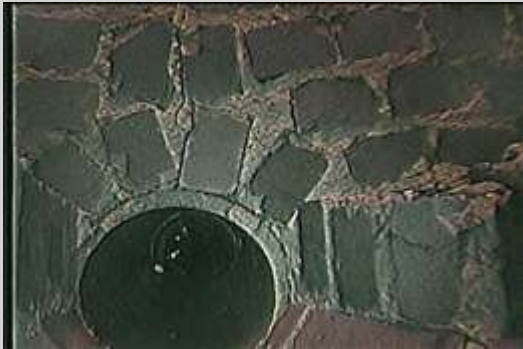
### 8 in. Circular Gravity Sewer Pipe Out @ 12 O'Clock

Comments **The O12 pipe seal is not flush to the pipe. The I3 pipe seal is not flush to the pipe.**

Barrel deterioration and infiltration.

Infiltration: **Evidence** Pipe Seal Cond: **Unknown**

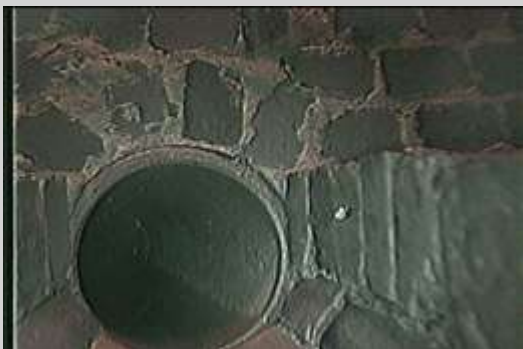
### 8 in. Circular Gravity Sewer Pipe In @ 3 O'Clock

Infiltration: **Evidence** Pipe Seal Cond: **Unknown**

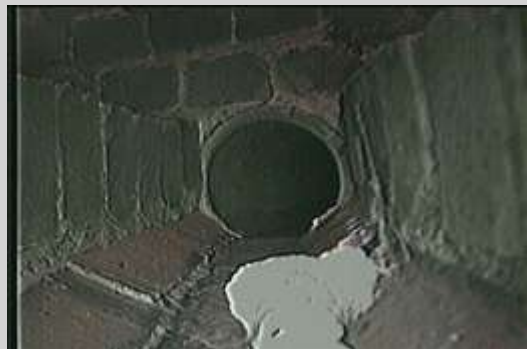
Pipe In @ 6 O'Clock

Infiltration: **Evidence**
